OCTOBER, 1929

BITUMINOUS SURFACE TREATMENT EXPERIMENTS IN DEPARTMENT OF AGRICULTURE GROUNDS

Reported by J. T. PAULS, Senior Highway Engineer, and PAUL F. CRITZ, Associate Highway Engineer, Division of Tests

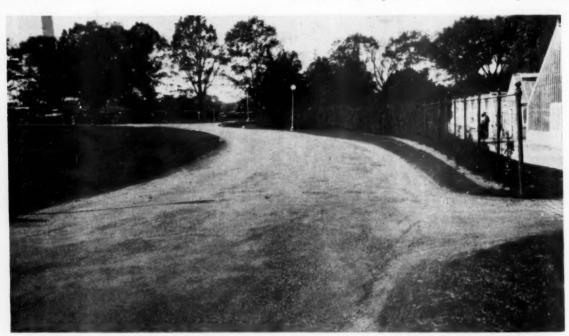
for the entire section. The central portion of the section has always required considerably more maintenance than the remainder and its condition at present, as illustrated in Figure 5, is probably worse than any other area included in the experiments. Its tendency to shove under traffic during very hot weather has recently required the extensive use of crushed stone in an attempt to stabilize the bituminous mat which is about 2 inches thick.

FIGURE 5.—PRESENT CONDITION OF THE CENTRAL PORTION OF SECTION 2. NO ING OF THE SURFACE MAT ALONG RIGHT SIDE NOTE HEAVY PATCHING AND SHOV-

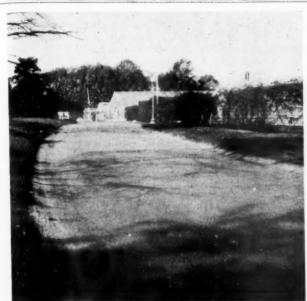
FIGURE 6.—PRESENT APPEARANCE OF THE EAST END OF SECTION 2. ALTHOUGH LYING IN A CUT THE BITUMI-NOUS GUTTERS AND NATURAL SLOPE AFFORD AMPLE DRAINAGE

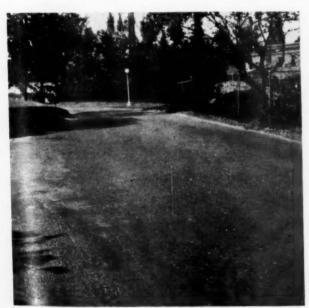
Section 3 is in excellent condition. Its surface is firm and smooth and shows no tendency to ravel although the coarse stone is exposed. Like section 2, it carries very heavy traffic traveling in both directions. The recent count showed a daily average of 5,213 vehicles. On several occasions the number of vehicles passing over the section exceeded 500 per hour. The gradual widening of the travel area along the edges has increased the width of the section to approximately 20 feet. Figures 7 and the cover page show the present condition of the section as well as its location which is mainly in a cut. The natural slope and the bituminous gutters provide satisfactory drainage.

FIGURE 7.—EAST END OF SECTION 3. PRESENT CONDITION

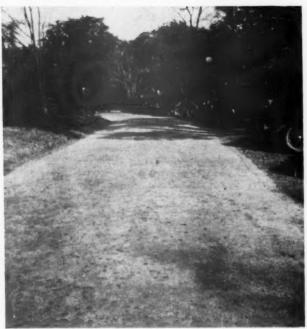
Section 4, which carries traffic in both directions, is in very good condition. Its surface, although very dull in appearance, is smooth and intact. Some breaking along the edges has been caused by vehicles leaving or coming onto the surface from the adjacent parking areas. The average daily traffic carried by the section, as shown by the 1928 count, was 305

FIGURE 8.—LOCATION AND PRESENT CONDITION OF SEC-TION 4. THE SURFACE MAT, ALTHOUGH INTACT, IS VERY LIFELESS IN APPEARANCE, DUE TO INSUFFICIENT TRAFFIC
